**MISSOURI-MADISON RIVER FUND
RECREATION PROJECT**

APPLICATION FORM 2008

Project Name: **Reconstruction of Roe River Bridge**

ATTACHMENT A
Reconstruction of Roe River Bridge
Excerpt from Seivert & Seivert Report

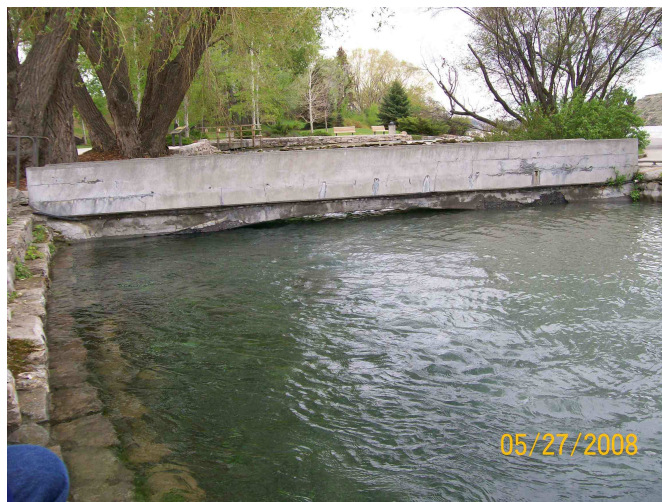
When the bridge was built, the water level in Rainbow Reservoir did not affect the bridge and the entire structure sat on dry land (see historic photo contained in Attachment B). In subsequent years, the height of Rainbow Dam located downstream of Giant Springs was raised, causing the waters of Rainbow Reservoir to back up into the Roe River. This resulted in the bridge abutments and lower portions of the bridge being submerged in water. Fluctuations in the reservoir levels can easily be seen on the bridge as they raise and lower. During high water periods such as those seen in May-June 2008, the water level rises well above the abutments and almost to the apex of the arch span (see Attachment B). The bridge has also been impacted by the addition of block railings, as well as age.

Photo of Seasonal High Water Conditions on Roe River Bridge taken 5/27/08

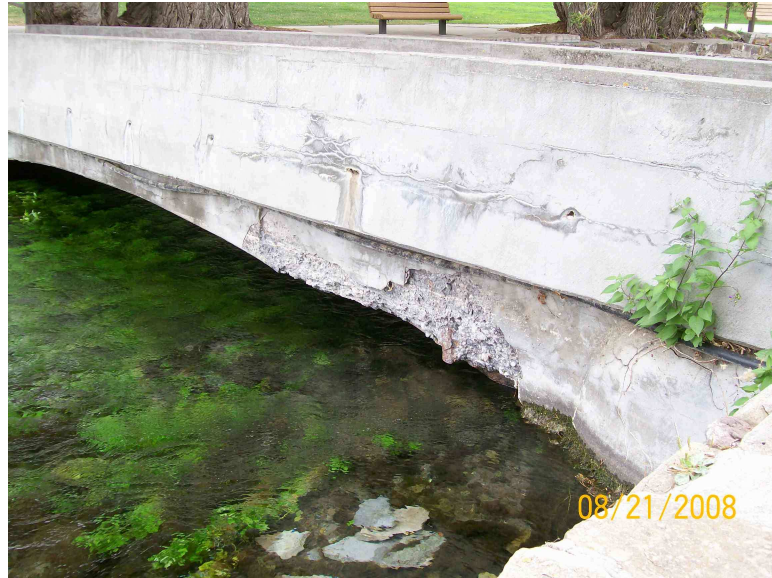
The concrete ribs exhibit significant spalling near the waterline at both springlines of the arch when viewed from the shore. This is attributed to water and freezing actions in the manner of bridge piers and abutments. In February 2007 FWP personnel and the author conducted an underside inspection of the bridge structure. The construction described above was confirmed during that inspection. The inspection further revealed that large sections of the concrete cover over the bottom reinforcing had spalled off, areas that had not spalled were badly cracked and ready to spall, and that the exposed tensile reinforcing at the bottom of the ribs was severely corroded and in some instances partially missing. Exposed reinforcing that is remaining is badly delaminated (lamellar delamination) and it fragmented when touched.

This single span bridge over the Roe River is in much worse condition than the (4) companion spans at the viewing bridge feature. This is attributed to the added weight from the deck overlay and cementitious railing that was added in the 1970's; the added weight opened the flexural cracks at the bottom of the ribs slightly and moisture more easily accessed the reinforcing. All deterioration appears to be water related; no evidence was found indicating material failure or chemical action causing deterioration of the bridge.

Photo Showing Spalling of Roe River Bridge – North Side

- Reconstruct the bridge including railing designs compatible with the historic railings used at the cantilevered viewing platform.
- Elevate the bridge (slightly) to improve the gradient at the south access for ADA
- Widen the bridge (1’ or less) to allow for mobility impaired to pass safely while on the bridge feature.

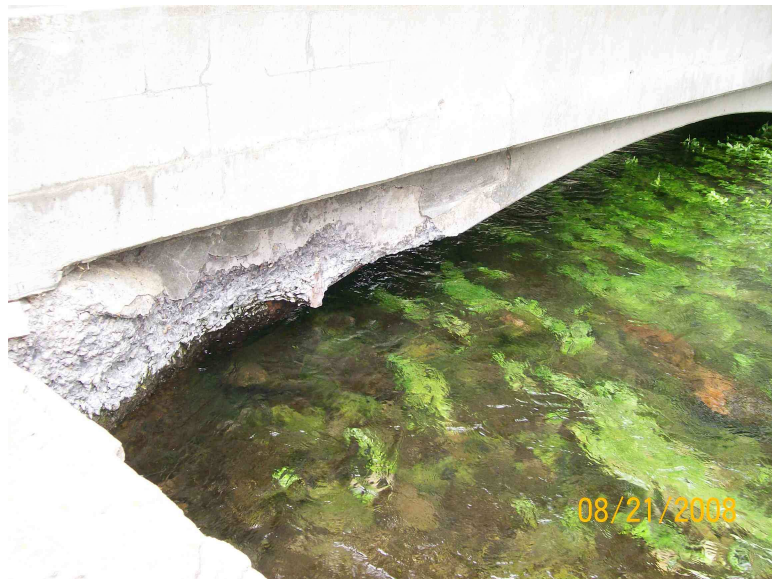
Photo Showing Spalling of Roe River Bridge – South Side
